Improving Condenser Reliability and Availability Through Effective Offline Cleaning and Nondestructive Testing

Eric H. Fayard
Conco Systems
Verona, PA USA

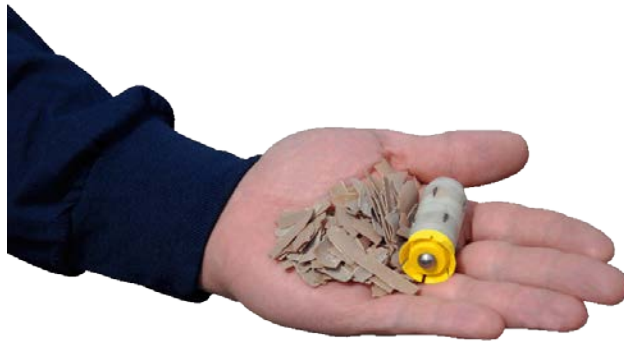
Figure 1: Scale as removed from condenser tubes

have these ions in varying concentrations based on local site conditions. Often managers, engineers, and chemists at plants with once-through cooling systems may only give passing thought to scale formation in condensers. This oversight can be costly because the water that comes in from the lake or river and is later discharged is not exactly the same. Unlike familiar compounds such as table salt or sugar, calcium carbonate is less soluble as temperatures increase, so as the cooling water warms in the condenser, scale formation is a distinct possibility as seen in Figure 1. Omaha Public Power District's North Omaha Station

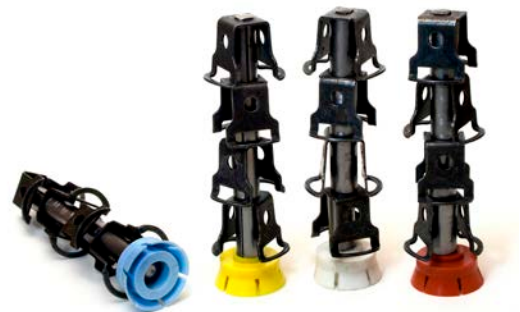
Figure 2: Mechanical Tube Cleaner

Mechanical cleaning is usually a very effective alternative. These techniques include high-pressure water washing, or shooting tube cleaners (Figure 2) through the tubes. When one balances the need for clean tubes vs. time required for the cleaning, mechanical tube cleaners are an excellent choice. High-pressure water washing can be very time consuming but using tube cleaner brushes for removing soft deposits or metal tube cleaners for more difficult deposits can be performed in a very short period of time. The

common procedure is for contracted cleaning company workers or on-site personnel to insert the tube cleaners in one section of the tube sheet at an inlet waterbox, and then, using pressurized water, shoot the cleaners through to the outlet water box, where those still in good shape are re-used, while old cleaners are discarded. Typically, metal tube cleaners can be used eight to twelve times before they become ineffective. Even with large condensers, cleaning may take only several days and can easily be incorporated into a scheduled outage, or period of reduced load.
