POWER PLANT CHEMISTRY®

Condenser Tube Fouling and Failures: Cause and Mitigation

Andrew G. Howell

George E. Saxon, Jr.

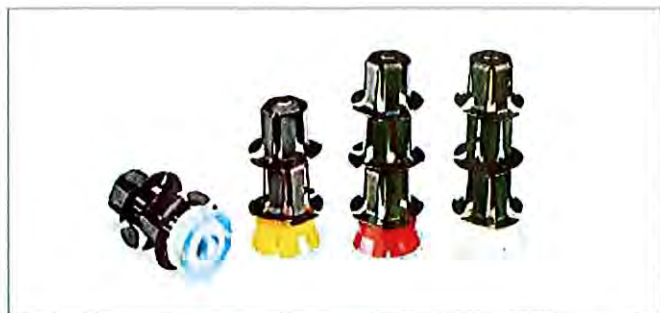
Figure 1: Metal tube scrapers, Hex Cleaners, for general purpose tube cleaning (Conco Systems, Inc.).

Several techniques are commonly utilized to mechanically remove foulants. Mechanical scrapers (metal or plastic) are widely applied, and specific scrapers have been designed to remove virtually all common foulants, even hard mineral scale such as calcium carbonate (*Figures 1 and 2*). Scrapers are propelled at $3\text{--}6 \text{ m} \cdot \text{s}^{-1}$ (10 to 20 ft/s) by pressurized water at about 2 MPa (300 psig), so loosened debris is rinsed from the tube with the scraping process. Concern has frequently been expressed regarding the affect of metal scrapers on base metal. Careful evaluation over many years has led to the conclusion that there is virtually no risk of base metal damage with metal scrapers that are properly designed and used [2]. One advantage of metal scrapers is that they are effective against a variety of foulants, so may be useful for general purpose cleaning if the foulant is not identified. However, some foulants are better removed by identification and matching with a specific scraper design [3].

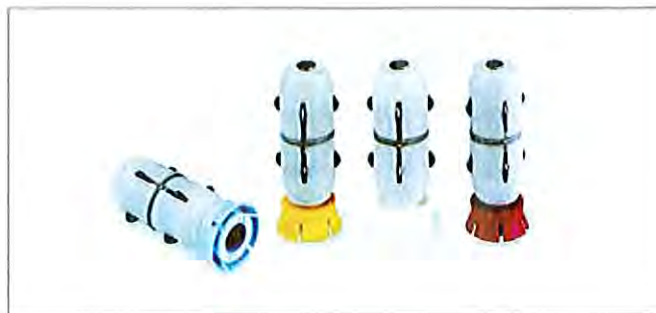
Figure 2: Cal Buster, designed for breaking up hard calcium carbonate scale (Conco Systems, Inc.).

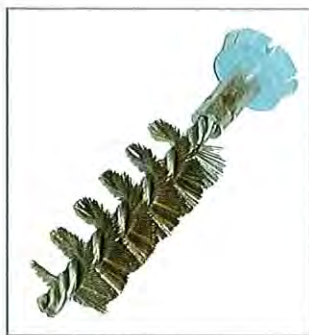
Figure 3: Stainless Steel Tube Cleaning Brush, for general purpose tube cleaning, including when scrapers will not fit properly due to inlet-end inserts or epoxy coating (Conco Systems, Inc.).

Other common mechanical foulant removal techniques include metal-wire brushes (*Figure 3*) and high-pressure water. Wire brushes are propelled individually down tubes, similarly to scrapers. Brushes may be particularly useful for tubes that have inlet-end metal inserts, or inlet epoxy coatings, which can reduce the internal diameter. High-pressure water ("hydroblasting") can be effective on some foulants, particularly soft materials such as microbiological films and particulate deposits, but may incompletely remove very adherent scales. Additionally, hydroblasting must be performed carefully, as the water will quickly cut through relatively soft condenser tubing (such as copper alloys) if the spray nozzle is allowed to pause for too long. Where inlet-end metal inserts are present, hydroblasting can severely deform the inserts by forcing water into the insert-tube interface.

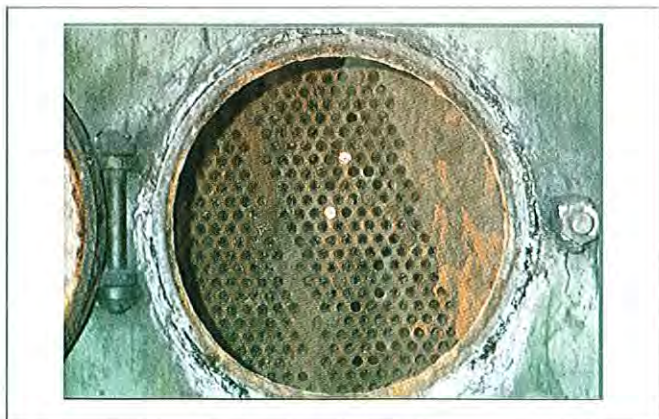
Figure 4: View of inlet-end tubesheet through manway; tubes are filled with microbiological slime that is dried and flaky.

Microbiological fouling can be removed by almost any mechanical cleaning technique, but can also be addressed by allowing the condenser tubes to dry out (*Figure 4*), and then flushing with water (returning to normal cooling water flow). This rather passive cleaning approach requires that the underlying foulant present is microbiological in nature, even if the bulk of the foulant consists of inorganic particles.

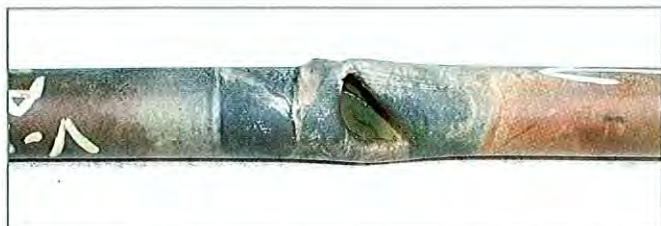
Figure 5: Admiralty brass tube, failed by impact damage due to unknown object propelled into condenser at startup, after turbine outage.

Steamside Failures: Mechanical Causes Impact damage is a common mechanical failure mechanism for all condenser tube alloys. Objects left in the system after a low-pressure turbine overhaul can be propelled into the condenser at high velocity during unit startup, and leave severe dents or holes upon impact (*Figure 5*).

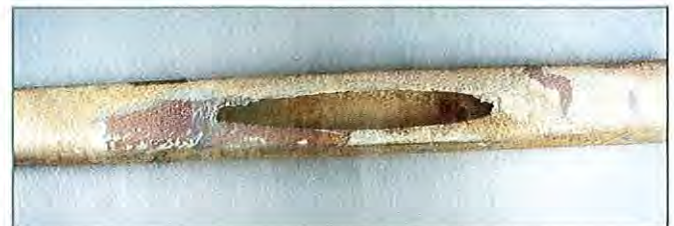
Figure 6: Admiralty brass tube, failed by drain line erosion due to failed valve.

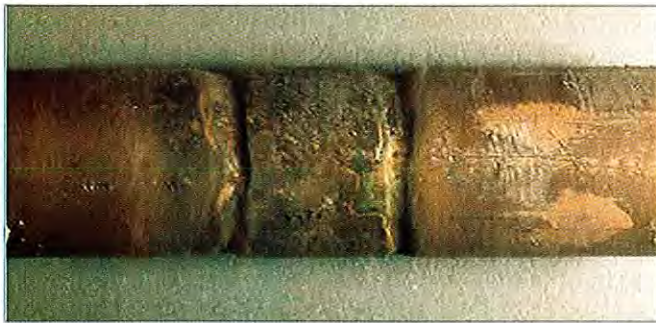
Figure 7: Ammonia condensate grooving in admiralty brass tube. Grooves formed on each side of tube support plate.

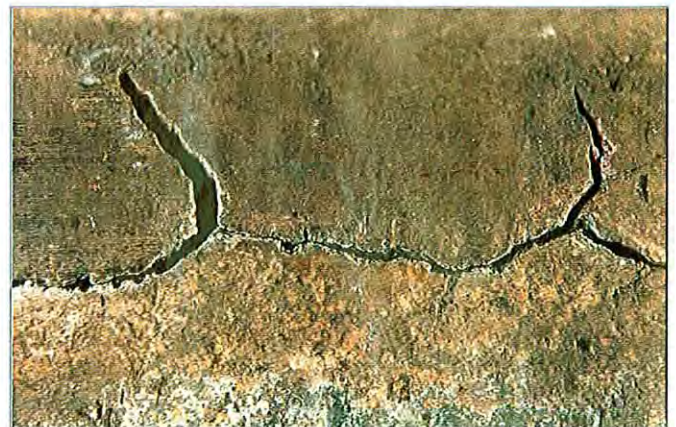
Figure 9: Stress corrosion cracking in admiralty brass tube due to carryover of sulfur dioxide, in sulfite-treated boiler. Magnification 4x.

Condensers with brass tubing have also experienced severe pitting and failures by SCC due to sulfurous acid, in systems where sodium sulfite is used for feedwater oxygen scavenging (*Figure 9*) [5,6]. Sulfite breaks down in the boiler to generate sulfur dioxide gas:

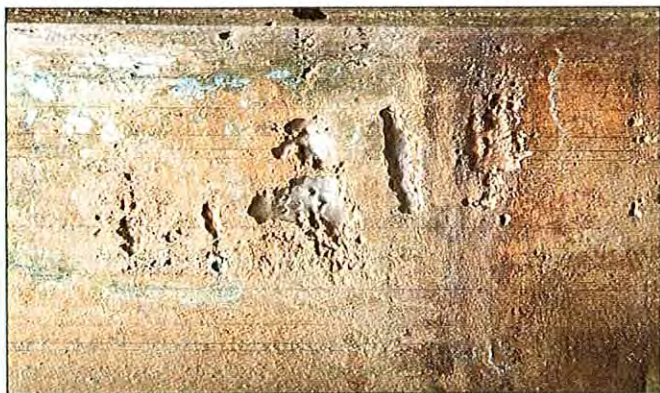
Figure 10: Inlet-end erosion-corrosion in admiralty brass tube. Magnification 3x.

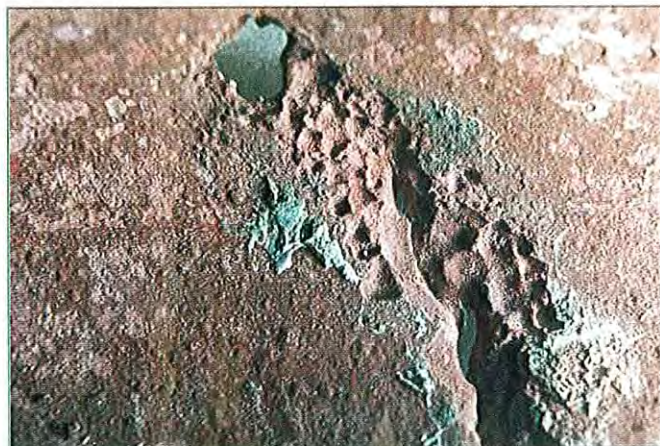
Figure 11: Erosion-corrosion failure in 90-10 copper-nickel tube, due to accelerated local flow around an object lodged in the tube. Magnification 4x.

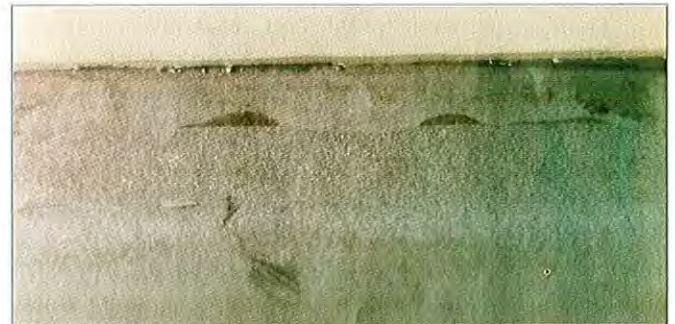
Figure 19: 304 stainless steel tube with defects at incompletely formed weld seam. Magnification 4x.

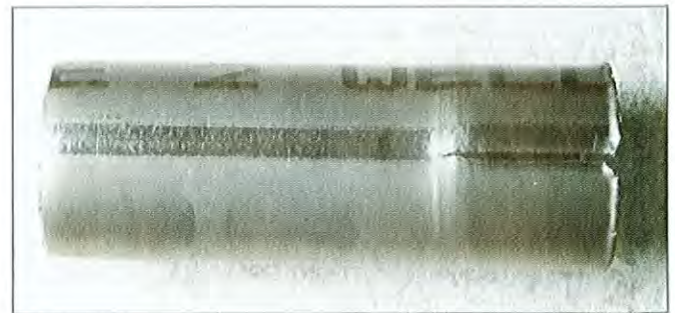
Figure 21: Titanium tube that failed at weld seam upon rolling into tubesheet, due to manufacturing embrittlement, combined with freezing while filled with water during temporary storage.

Condenser tubes may fail in service due to specific situations other than the service environment. Off-line chemical cleaning, if not accomplished properly, can cause tube damage that later results in failures (Figure 18). Manufactured defects, such as incomplete or improperly formed weld seams, or denting during handling, can lead to failures (Figures 19 and 20). During tube installation, rolling tubes into the tubesheet requires precise quality control to avoid excessive stresses or crevices (Figure 21).
