Jet News **October 2015**

Optimum Heat Exchanger Performance Depends On Clean Tubes

By Jennifer Larson, Conco Industrial Services

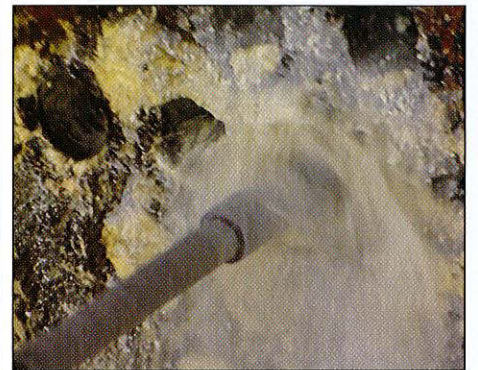
HydroDrilling a Sulfur Recovery Unit

product or the freezing of polymer products on the heat exchanger surface. In both cases, if the fouling is extremely tenacious, drilling in conjunction with a flow of low-pressure water (hydrodrilling) may be the most effective method of cleaning.

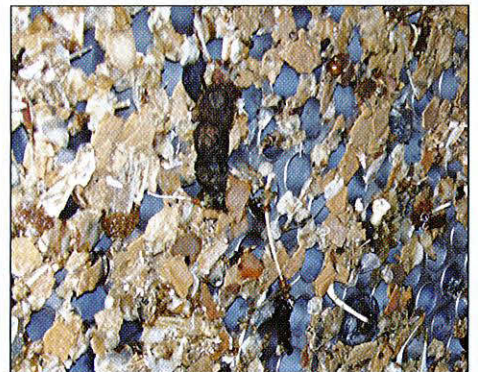
Macro Fouling Inhibiting Flow

A heat exchanger's inlet tubesheet is the entry point into hundreds or even thousands of heat exchanger tubes. Macro fouling of this important gateway can cause heat exchanger efficiency problems. When sea water is used for cooling, the most frequent culprits of macro fouling are aquatic wildlife and shellfish. Debris often makes its way to the tubesheet in spite of filters that are in place at most plants, causing partial blockages and reduced flow through the heat exchanger tubes. The resulting partial flow blockage will allow particulates to accumulate, and local flow around

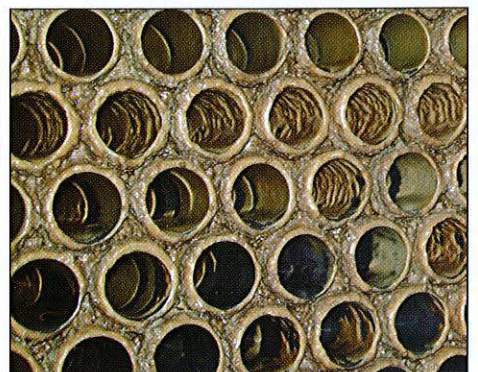
Scale Build-up on Tubes

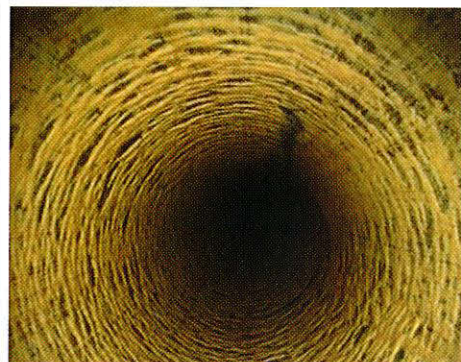
Stainless Steel Tube with Scale Deposits

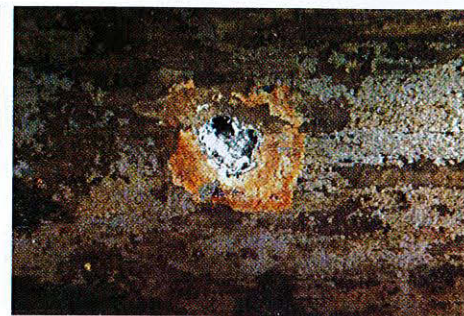
Under Deposit Corrosion - Pitting Due to Manganese Deposit

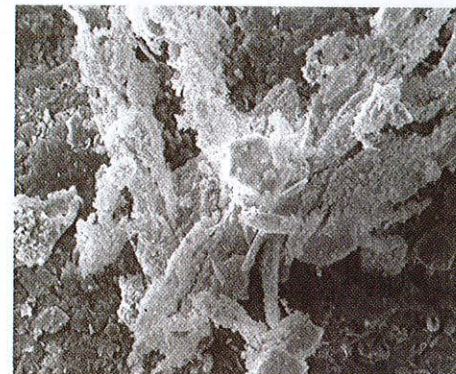
Silica Deposit at 500X Magnification
